Public Works Building and Annex
611 Walker Street

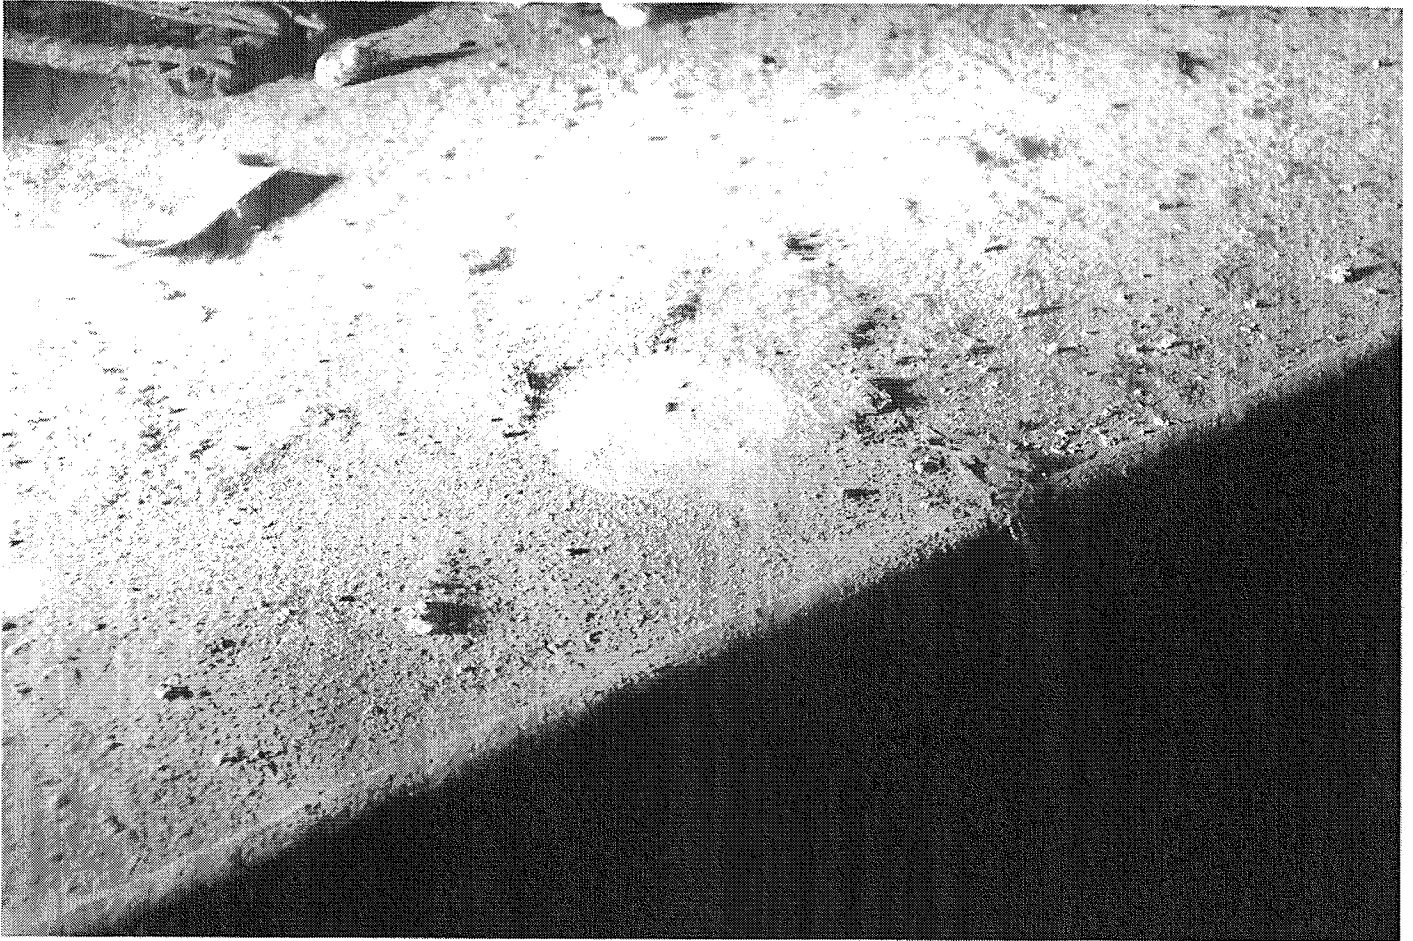
61. 1st floor, in SW pipe shaft - Location of dust sample #10

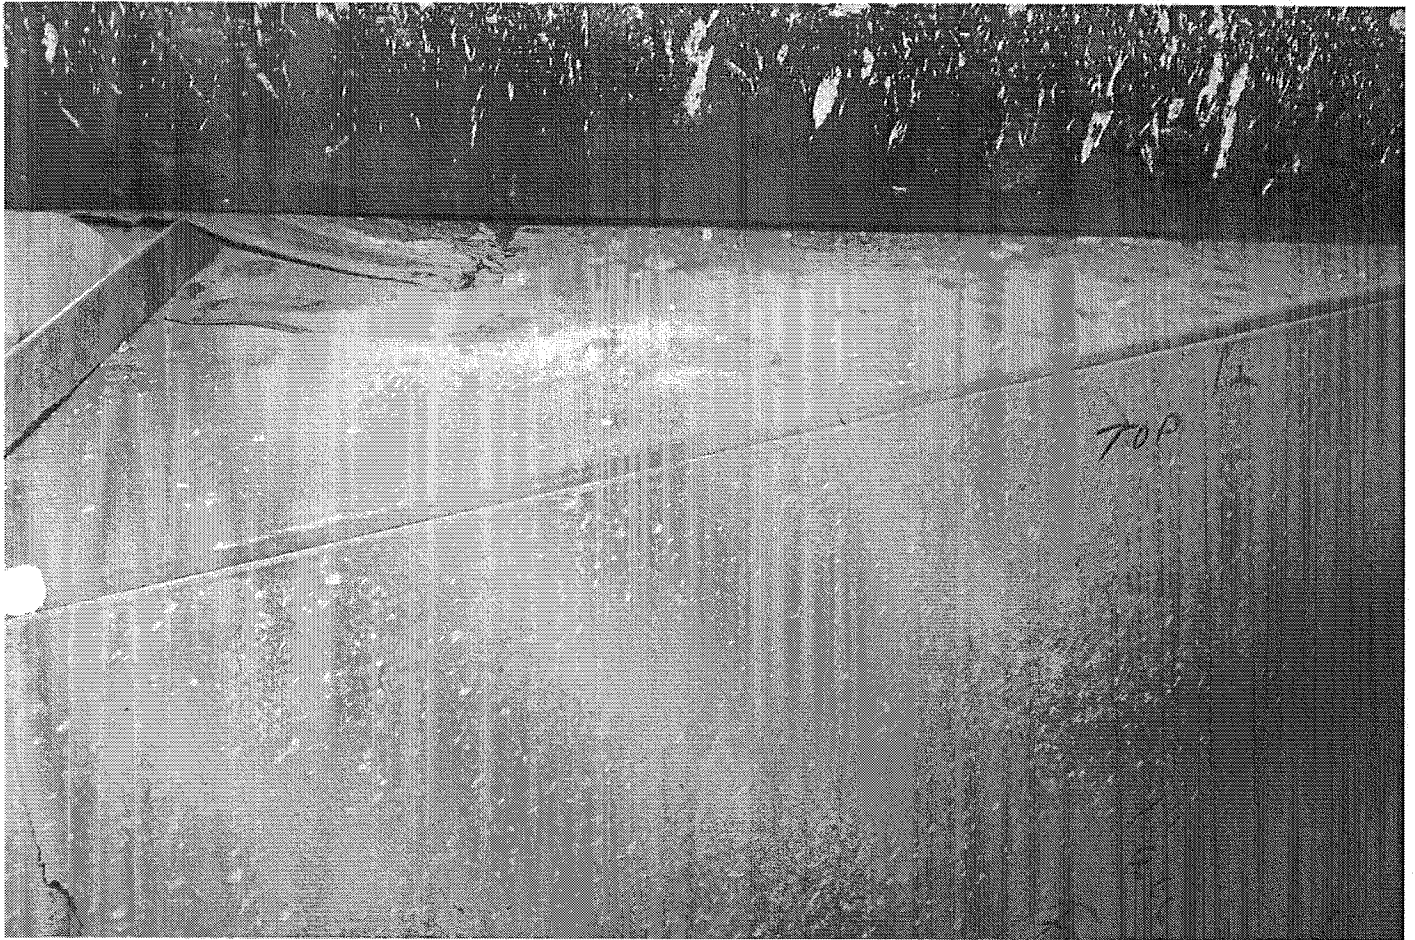
62. 1st floor, in SW pipe shaft - View of delaminated fireproofing debris on top of HVAC ductwork

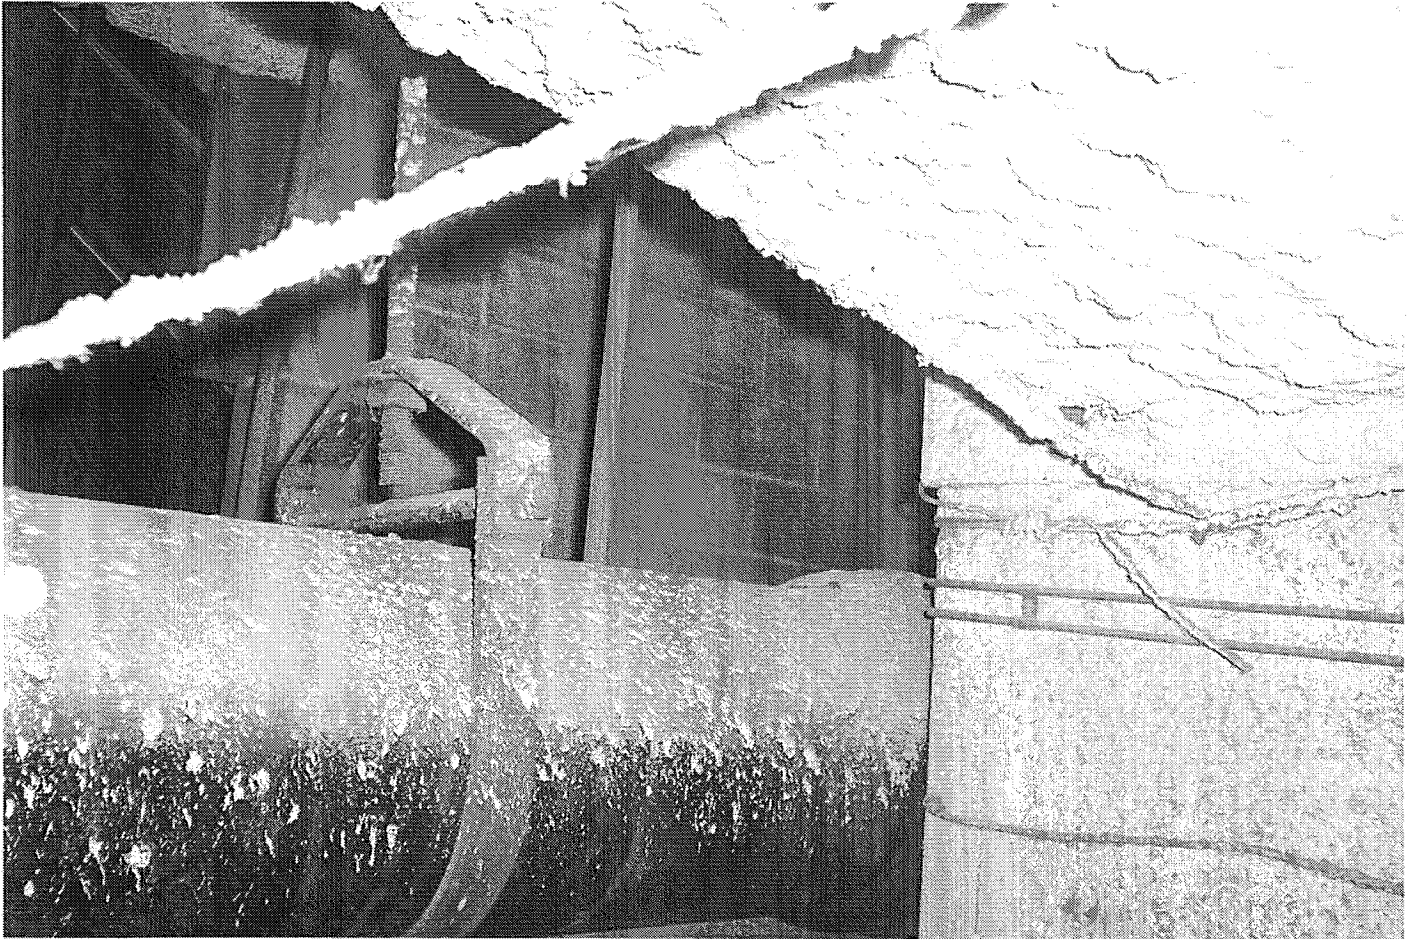
63. 1st floor, in SW pipe shaft - View of fireproofed beam and overspray on adjacent piping
